NAUGATUCK RIVER BASIN
OXFORD, CONNECTICUT

SWAN LAKE DAM
CT 00328

PHASE I INSPECTION REPORT
NATIONAL DAM INSPECTION PROGRAM

SEPTEMBER 1980

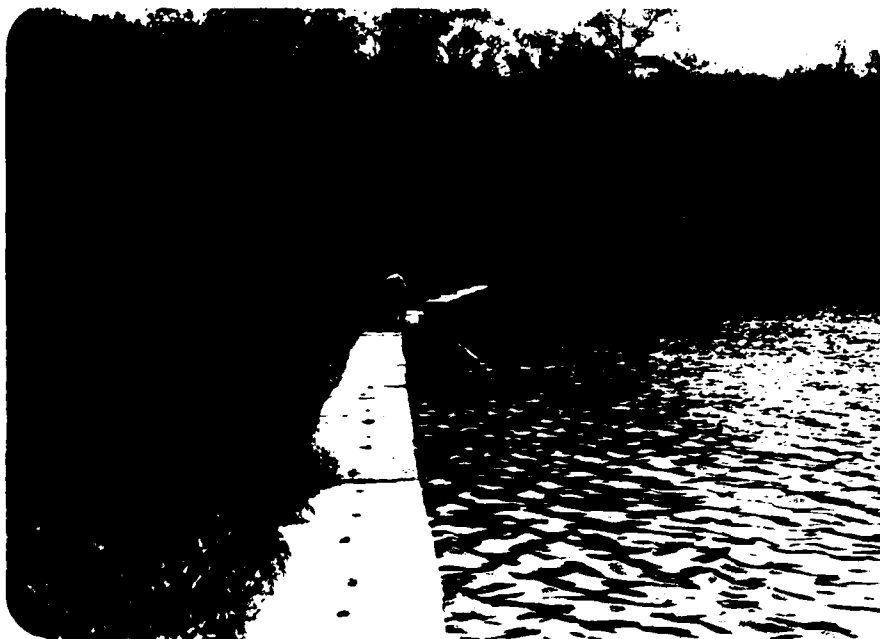
PHOTO NO. 1

DAM FROM LEFT END. NOTE DISPLACEMENT
OF UPSTREAM WALL AND BRUSH ON CREST OF DAM.

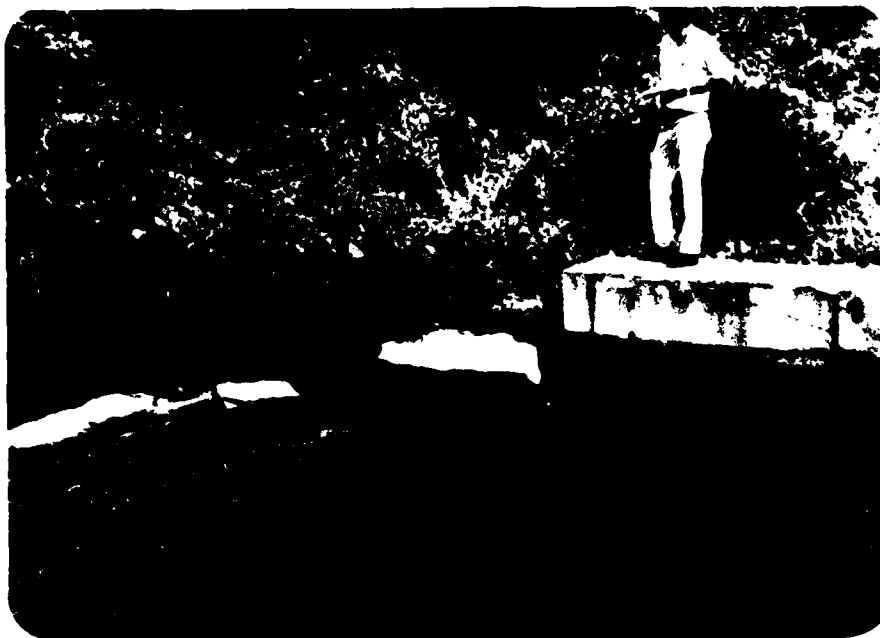
PHOTO NO. 2

The upstream face of the dam and the spillway training walls consist of 6 feet long by 3 feet wide by 1.5 feet high concrete blocks stacked two rows high with staggered joints, Photo 2. Open joints up to about 1 inch wide were observed between adjacent blocks. At a few locations, the wall showed evidence of up to several inches of settlement, lateral displacement or tipping, Photo 1. Directly behind the wall several depressions up to 16 inches deep and about 1 foot wide were noted above the joints in the lower row of blocks, Photo 3. There is some erosion around the ends of the block wall at both abutments and at the spillway, Photo 2.

RIGHT SPILLWAY TRAINING WALL. NOTE
EROSION AT DOWNSTREAM END OF WALL.

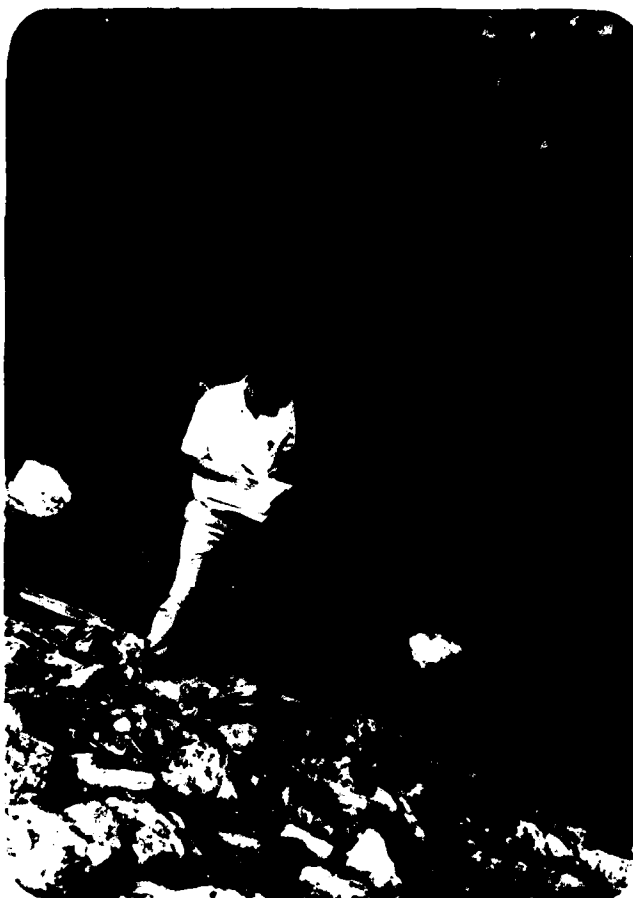
PHOTO NO. 10

DOWNSTREAM FACE OF
SPILLWAY AND DOWNSTREAM
CHANNEL VIEWED FROM
SPILLWAY CREST.
